AGARD Corrosion Handbook Volume 1 Aircraft Corrosion: Causes and Case Histories

AGARDograph No.278
AGARD CORROSION HANDBOOK
VOLUME 1

AIRCRAFT CORROSION: CAUSES AND CASE HISTORIES

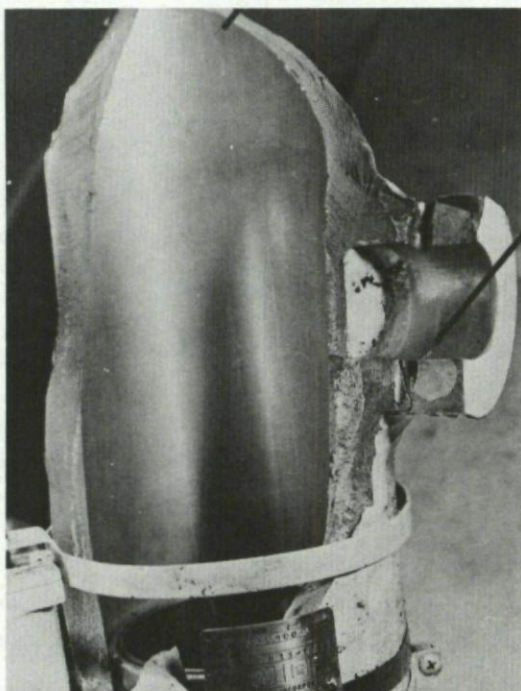
The nose landing gear strut of a fighter aircraft failed during a normal landing procedure after only 30 hours of flight had been accumulated. The failed part is shown in Figure 13-35, and closer examination of the fracture surfaces evident in the failed part revealed that pre-existing cracks had been present prior to the final failure. The fracture surfaces due to these pre-existing cracks are shown in Figure 13-36, and it can be seen that these had initiated at the corners of the bore holes used to locate the clamping attachment bolts for the retraction cylinder.

Fig. 13-35 Stress corrosion cracking in a 7075-T6 nose landing gear strut, case history 13-7.

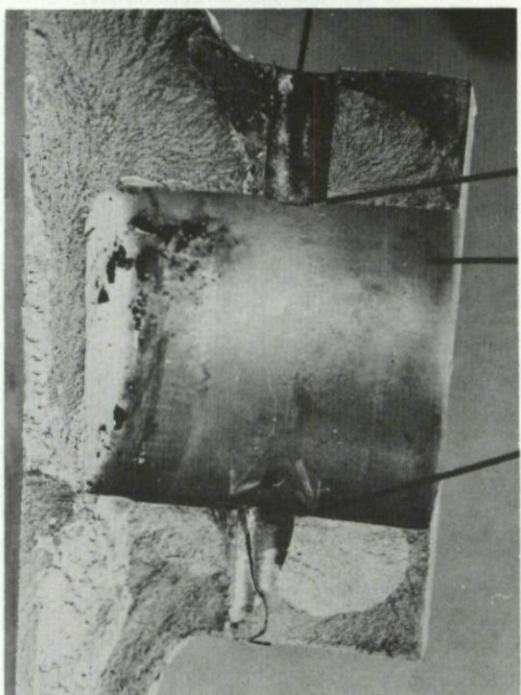
Fig. 13-36 Close-up of the stress corrosion crack initiation sites and the internal surface of the bore used to locate the retraction cylinder. Pitting can be seen at the base of this hole, case history 13-7.

The failure was a classical stress corrosion cracking problem and was influenced by the use of a susceptible material, the bored holes exposing end grain boundaries, assembly stresses due to interference fit bushings, and superimposed stress concentrations due to the intersecting bores. It was likely that high residual stresses were also present as a result of the T6 heat treatment.

A number of alternative designs were considered to resolve this problem including the use of one of the newer high strength, stress corrosion resistant forging alloys such as 7050-T73. However, it was decided to change to a high strength low alloy steel, AMS-6427 (0.3% C, 0.9% Cr, 0.2% Cu, 0.9% Mn, 0.42% Mo, 1.9% Ni) which provides higher strength together with good stress corrosion resistance. The design was also changed, replacing the clamping attachment bore with a forged steel pin, as indicated in Figure 13-38. The steel forging was protected by a vacuum deposited layer of cadmium plating followed by a layer of epoxy primer and a single coat of polyurethane paint.

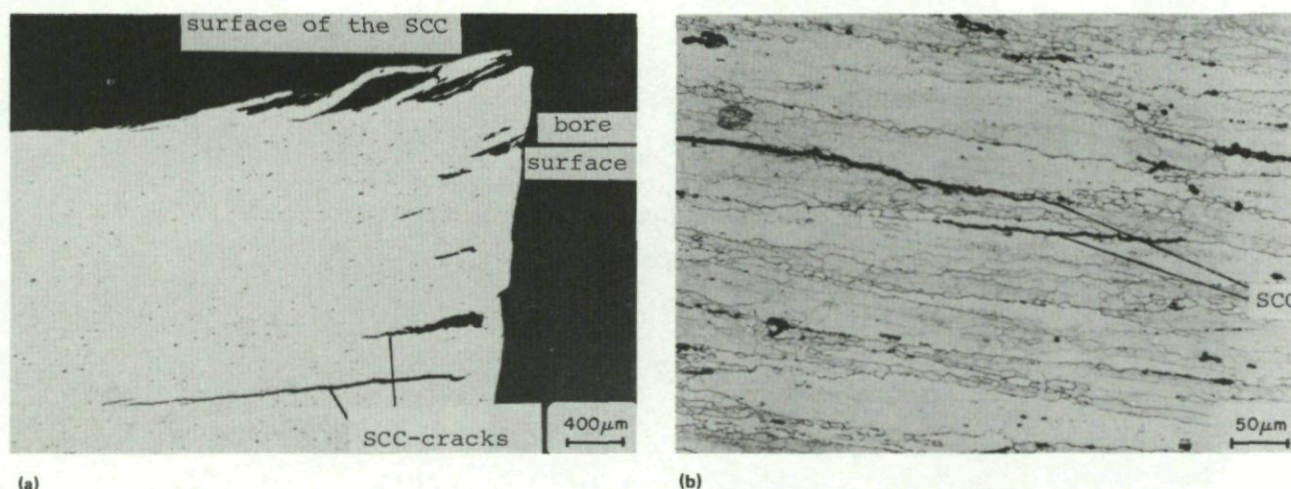
Fig. 13-37 Cross sections through the nose landing gear strut adjacent to the retraction cylinder bore and bolt hole, case history 13-7.

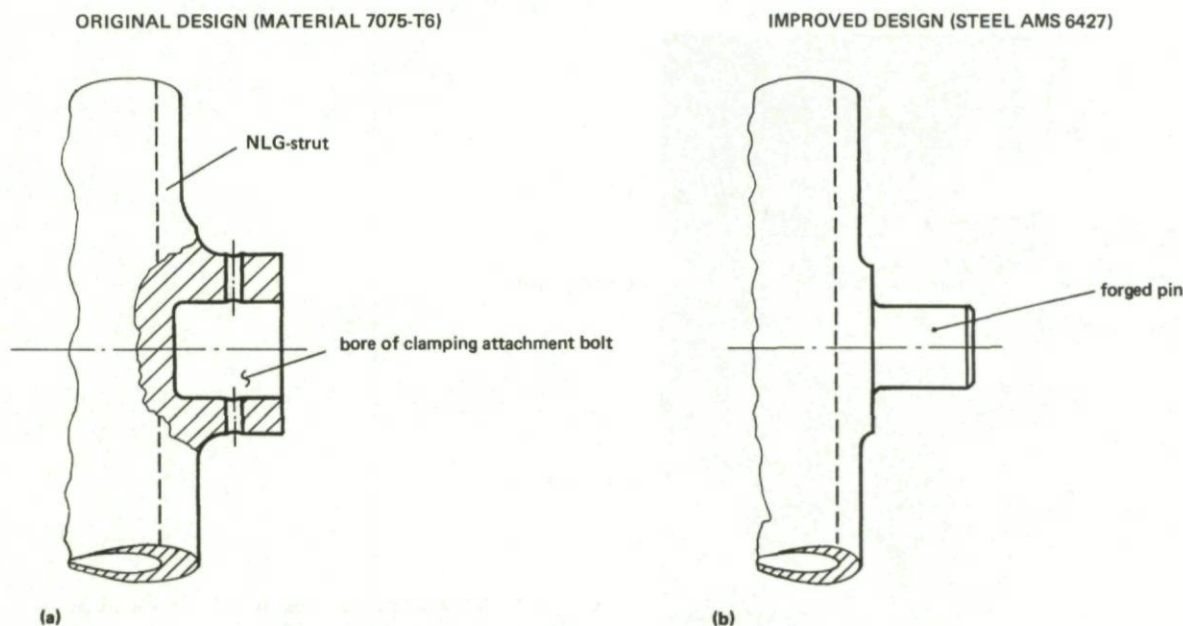
Fig. 13-38 Design details of the nose landing gear strut, case history 13-7.

- (a) Original design.
 (b) Modified design.

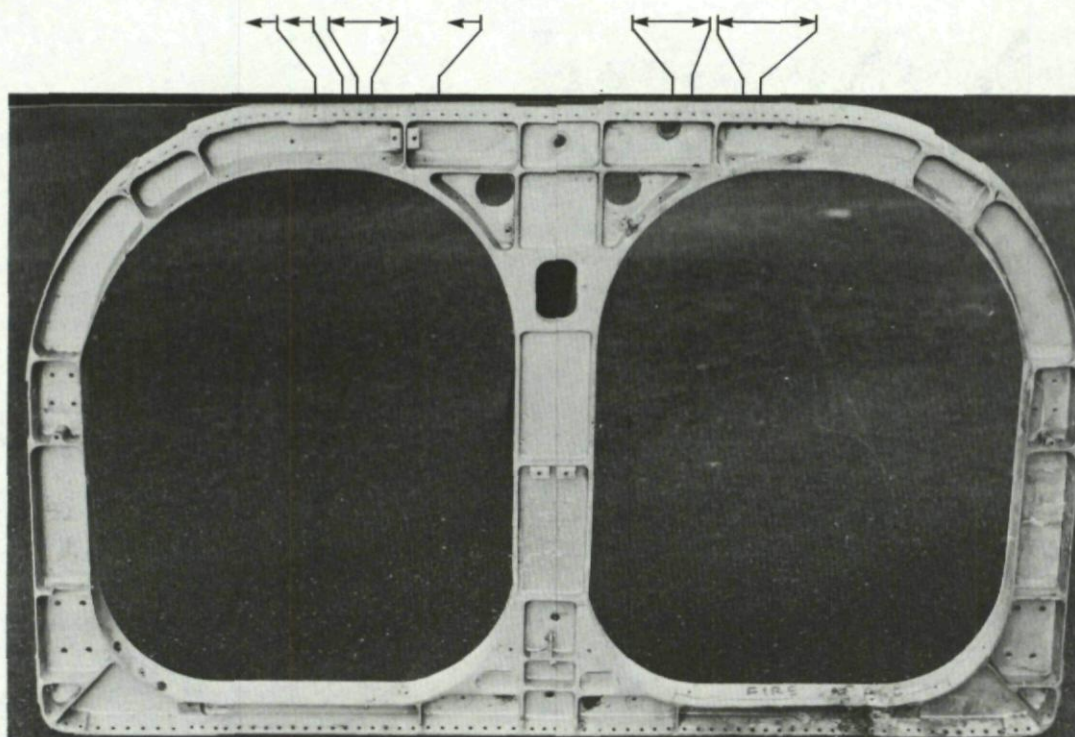
Fig. 13-39 Stress corrosion cracking in a 7075-T6 fuselage frame, case history 13-8. Arrows indicate the directions of cracking away from fastener holes.

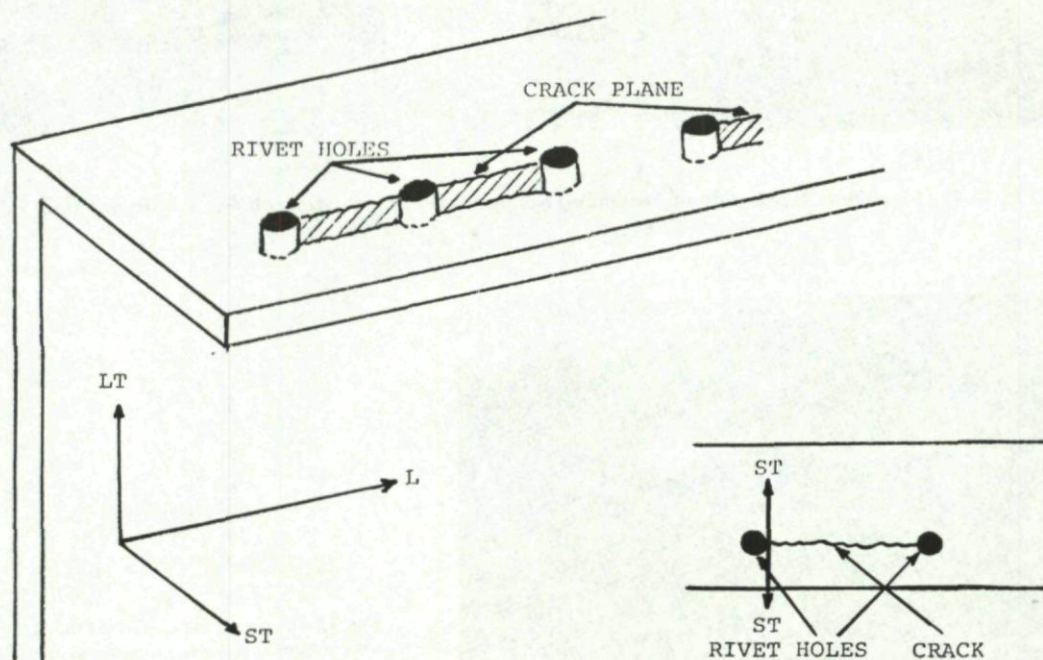
A spectrographic analysis showed the alloy contained 3% Mg, 5.1% Zn, 1.8% Cu, 0.18% Cr and lesser amounts of Fe, Si and Mn. The alloy concentrations were consistent with specifications for 7075 and the alloy hardness indicated the material was in a T6 strength condition. A microstructural evaluation of the grain structure showed a heavily wrought structure of pancake shaped grains, where the crack plane was coincident with the plane containing the longitudinal-long transverse directions, and the short transverse direction was normal to the crack plane as indicated in Figure 13-40.

Fig. 13-40 Orientation of the crack plane with respect to the principal directions in the fuselage frame, case history 13-8.

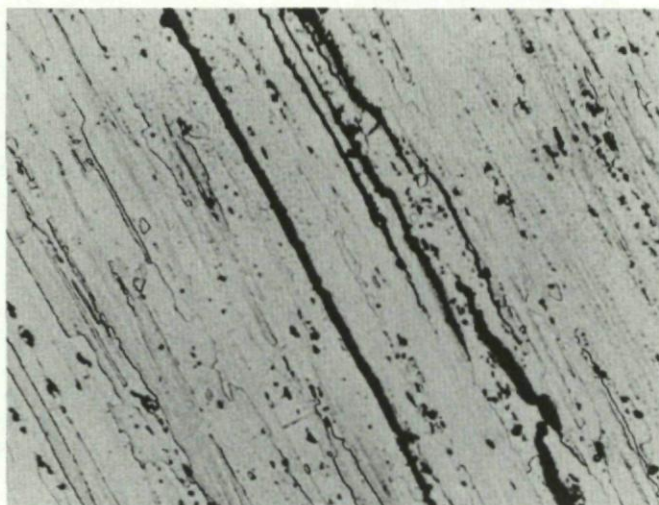
Figure 13-41 shows a metallographic section normal to the LT direction and cracks can be seen running in the longitudinal direction along grain boundaries. The fracture surfaces were corroded, and in most cases they showed no recognizable feature other than flat grain boundary surface facets, as shown in Figures 13-42(a) and 13-42(b), and secondary cracking (Fig. 13-43). In a few cases striation like markings were present immediately adjacent to the fastener holes and in most cases the surfaces of the fastener holes contained corrosion pits. The failure analysis report made no mention of sealants or other forms of corrosion protection in the fastener holes and no information was given on the fastener materials used. However it was concluded that cracking was due to stress corrosion, initiating at corrosion pits in the bore of the fastener holes. The stresses were believed to be due to assembly and operating loads and a stress analysis showed that stresses in the ST direction in the region of the fastener holes were in excess of the threshold values for stress corrosion cracking given in Reference 13-1, Table 13-1.

Fig. 13-41 Metallographic section indicating the intergranular crack path in the fuselage frame, case history 13-8.

It was recommended to replace these fuselage frames with 7075-T73 to prevent SCC. However, since there was evidence of fatigue in some areas and since threshold stress intensities for fatigue in 7075-T73 are slightly lower than for 7075-T6 it might be preferable to replace this alloy completely with a higher strength stress corrosion resistant alloy such as 7050-T73. Wet assembly of fasteners should also assist by excluding moisture from the fastener holes.

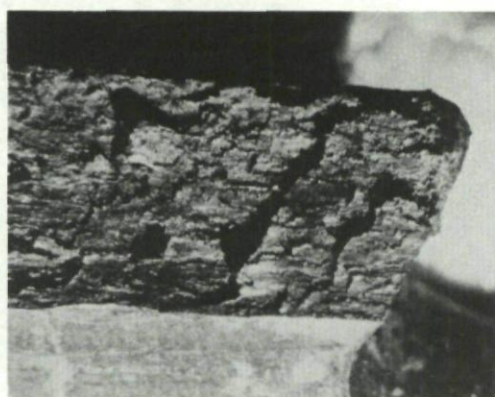
Fig. 13-42 Fracture surface topography extending between two adjacent fastener holes, case history 13-8.

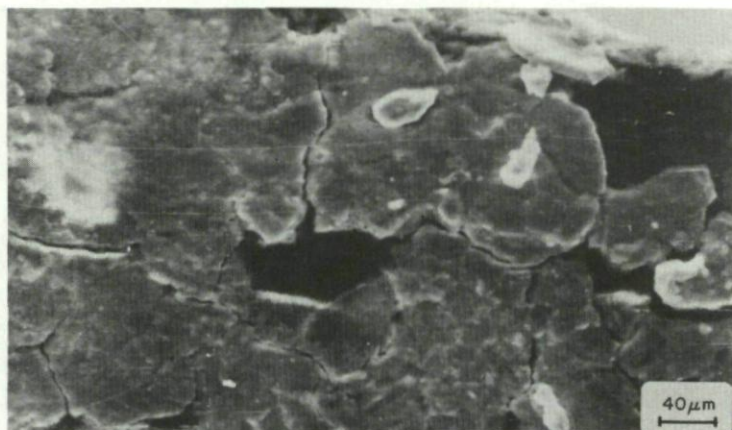
Fig. 13-43 Scanning electron micrograph of a fracture surface from case history 13-8, showing secondary intergranular cracking.

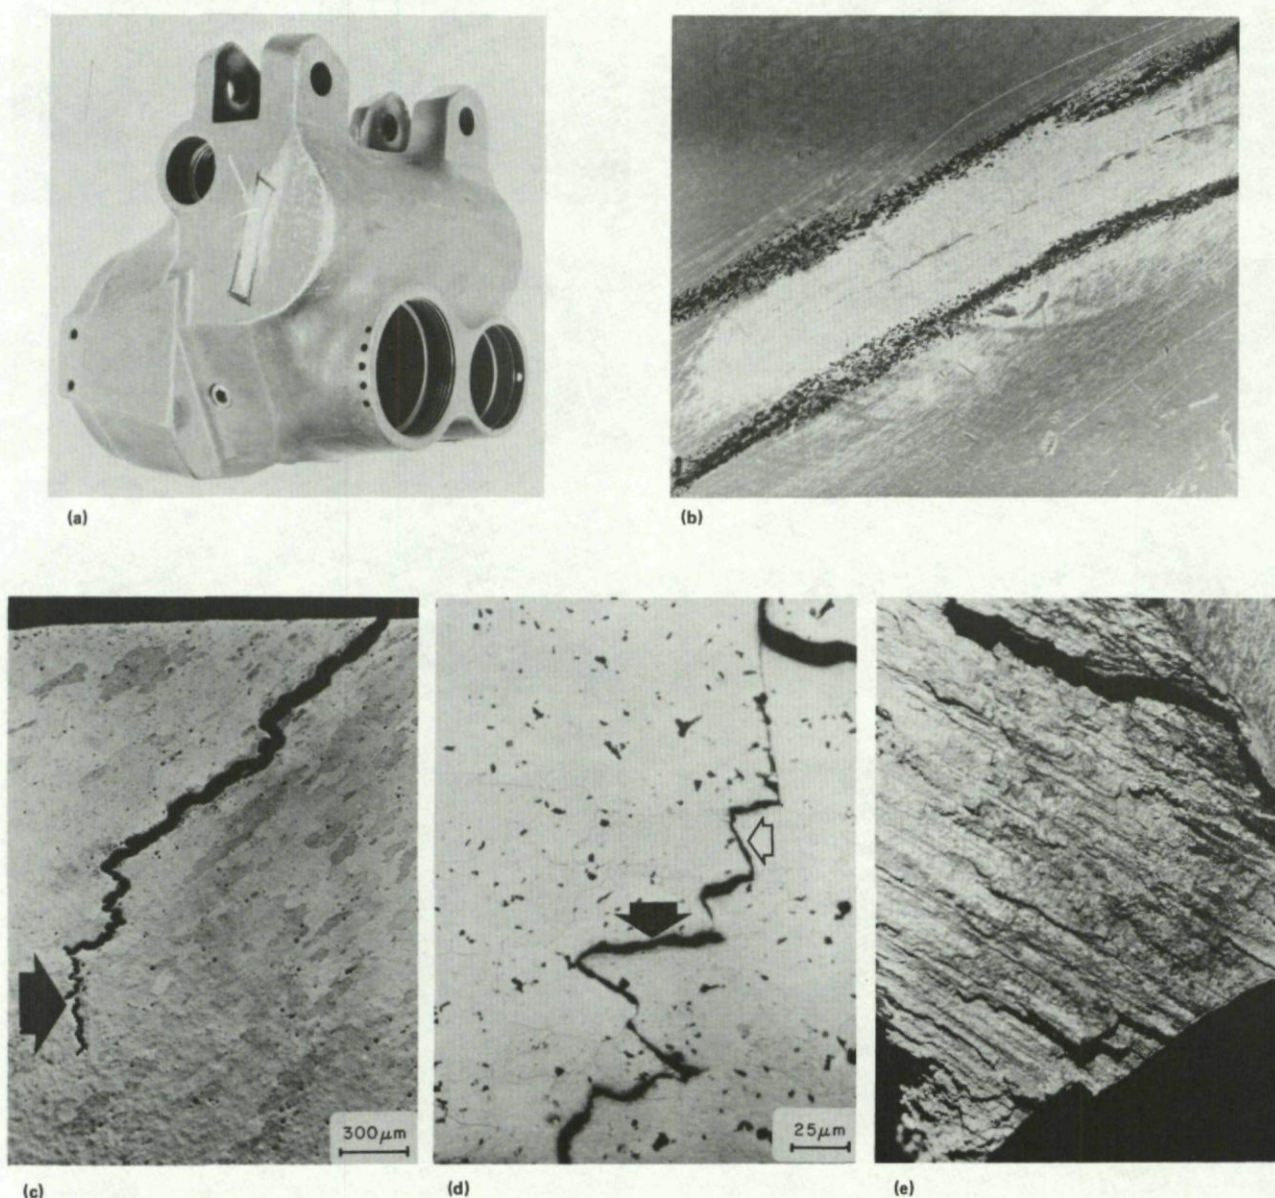
Fig. 13-44 Cracking in a 2014 aluminium nose wheel steering damper, case history 13-9.

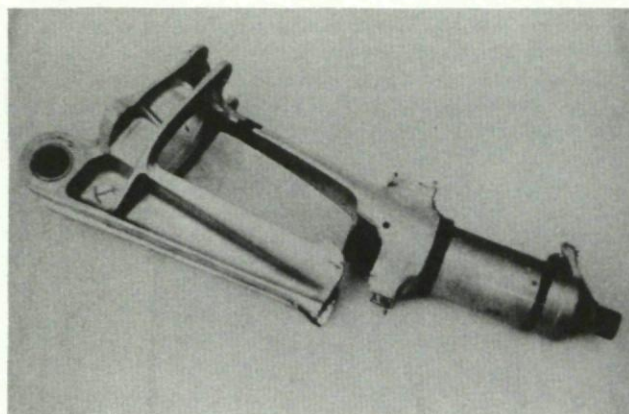
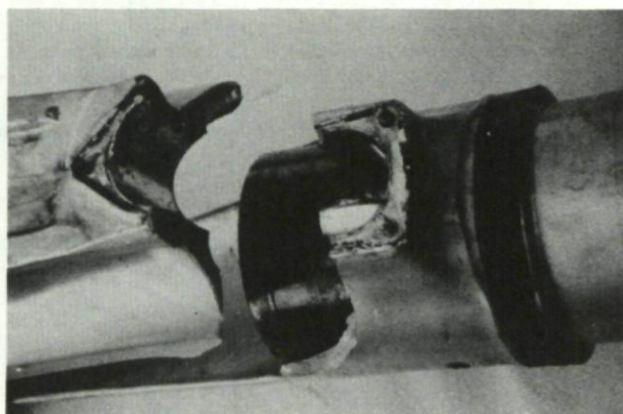
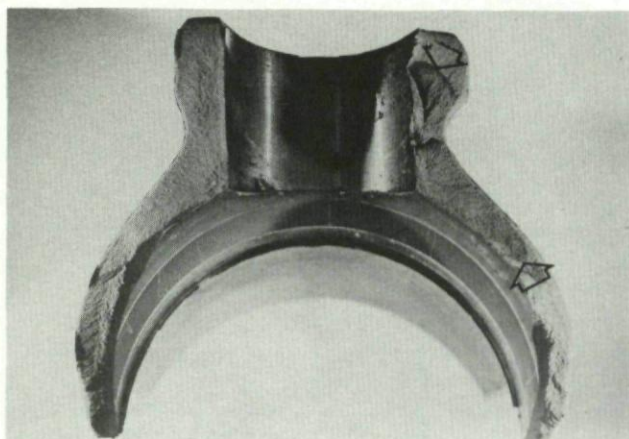
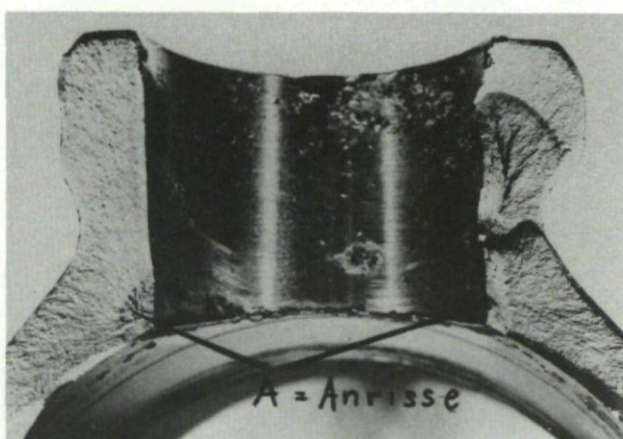
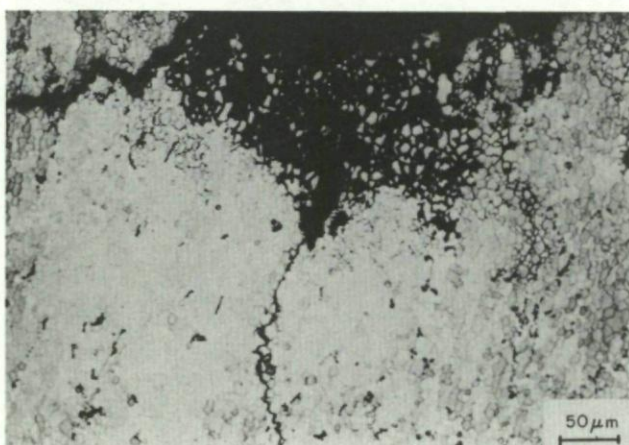
A landing gear forging of an aircraft, Figures 13-45(a) and 13-45(b) failed during ground operations. The crack initiated on an interior surface at the junction of an axial bore and a radial bore, Figures 13-45(c) and 13-45(d). The fracture surface to the right of the radial bore, see Figure 13-45(c), contained a dark corroded area, which had propagated to a considerable length as indicated by the open arrows. This was surrounded by a light, non-corroded, overload region which formed a narrow band between the dark corroded region and the outer surface of the part. This indicates that the growing crack had not broken through to the outside until the final overload failure had occurred, and therefore the pre-crack had remained hidden until this final failure. The presence of the narrow band of overload fracture suggests that growth of the pre-crack had been suppressed by compressive residual stresses in the surface layers, which presumably did not exist, or had been removed by machining on the interior surfaces. Figures 13-45(c) and 13-45(d) show that severe corrosion and pitting occurred on the interior surface of the radial bore, and deep corrosion pits were present in the crack initiation regions.

Fig. 13-45 Failure of an Al-Cu main landing gear part, case history 13-10.

- (a) Fracture component.
- (b) Close-up of the fracture area.
- (c) Arrows indicate the extent of corrosion induced cracking.
- (d) Crack initiation sites at the junction of the axial and radial bores.
- (e) Sub-surface intergranular cracking adjacent to the radial bore.
- (f) Sub-surface intergranular cracking adjacent to the axial bore.

It was concluded that the failure occurred by stress corrosion cracking and this produced the dark pre-crack shown in Figures 13-45(c) and 13-45(d). Although the strength of the alloy was not given in this failure report, it is known that alloys of this type are sensitive to intergranular corrosion and stress corrosion cracking, particularly when heat treatment leads to the formation of solute-depleted regions adjacent to grain boundaries which are anodic with respect to the grain boundaries and grain interiors. Little specific data appears to be available on 2017 aluminium, but Reference 13-45 indicates that stress corrosion service failures can be expected in 2017-T4 or 2017-T451 when sustained tensile stress acts in the short transverse direction relative to the grain structure. In this particular component there was very little directionality in grain structure, but as indicated in Section 13-5 equiaxed structures of the type observed might represent a worst-case condition with respect to SCC.

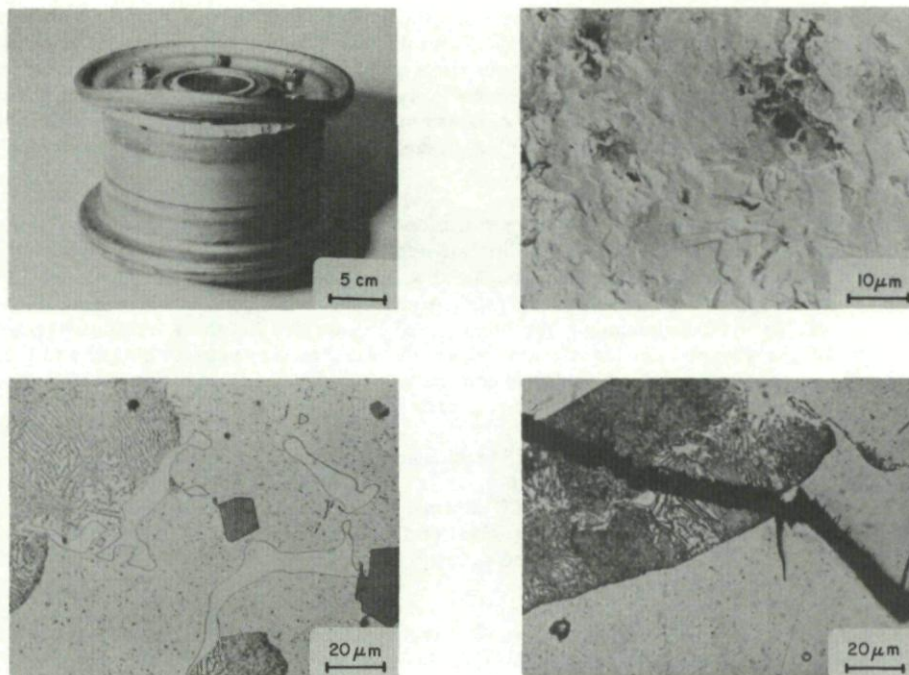
A magnesium alloy nose-wheel of a fighter aircraft failed and caused a tire blow-out. The wheel was produced as a casting using the MgAlZn alloy, AZ-91C, and this failed through the formation of a major crack in the fillet between the flange and the rim. This crack had caused the flange to be partly torn from the wheel body, as shown in Figure 13-47(a). Visual inspection revealed corrosion pits and small cracks in the fillet between the flange and the rim at the surface of contact with the tire-bead. The fractographic investigation failed to reveal any indications of fatigue or intergranular failure. The fracture surfaces were dirty and severely damaged, and the only recognizable features were lamellar components of the microstructure protruding from the fracture surface at various angles, as indicated in Figure 13-47(b).

Fig. 13-47 Stress corrosion cracking of a magnesium alloy nose wheel, case history 13-12.

- (a) Fractured wheel.
- (b) Fracture surface topography.
- (c) Microstructural constituents.
- (d) Section through a crack showing transgranular propagation.

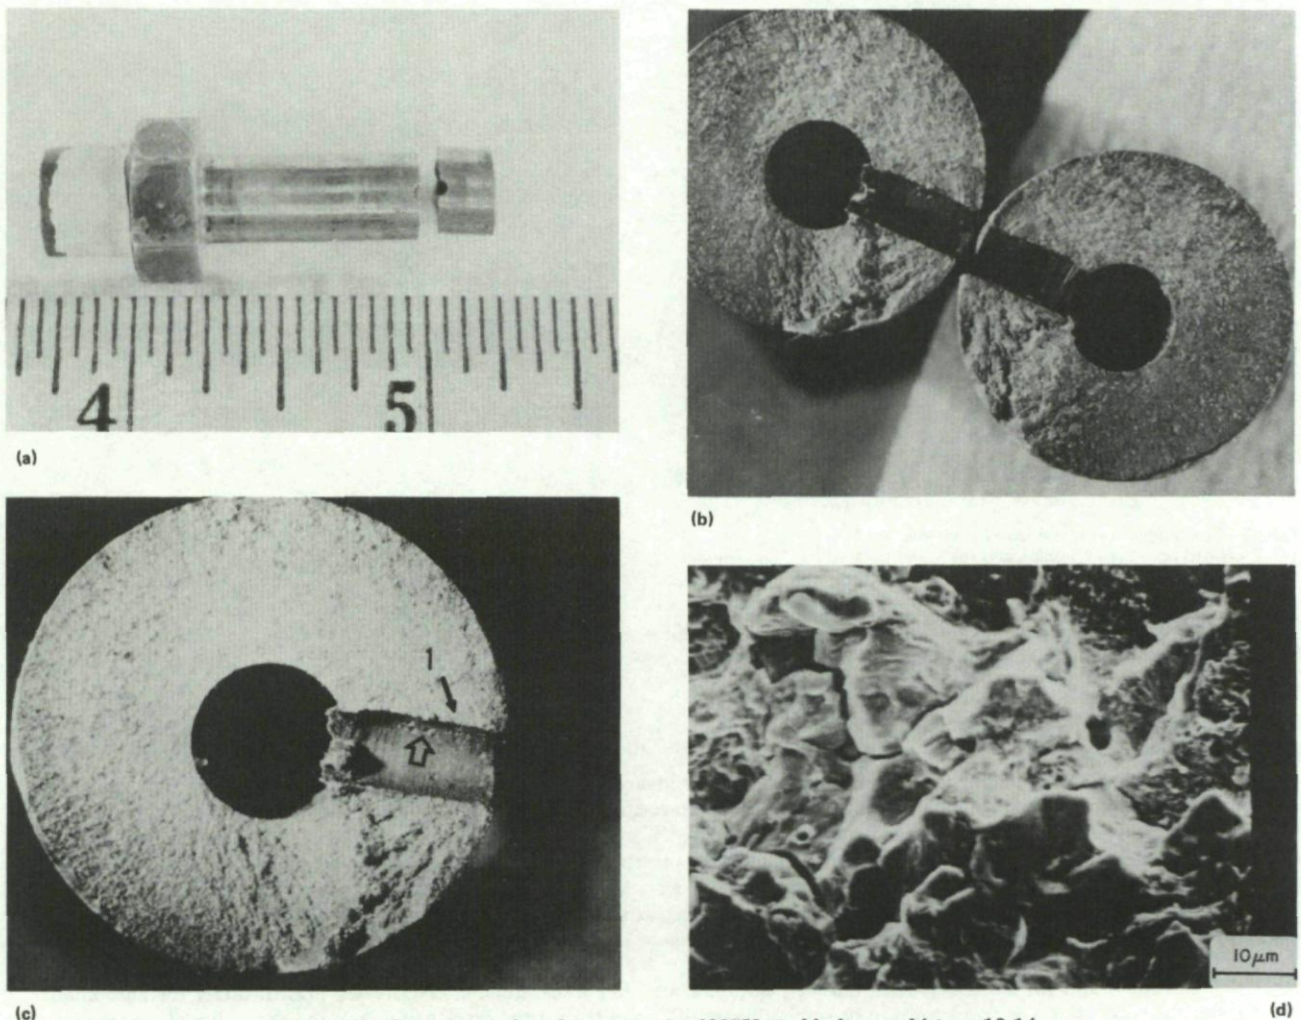
Fig. 13-49 Corrosion induced fracture of a 4335V steel bolt, case history 13-14.

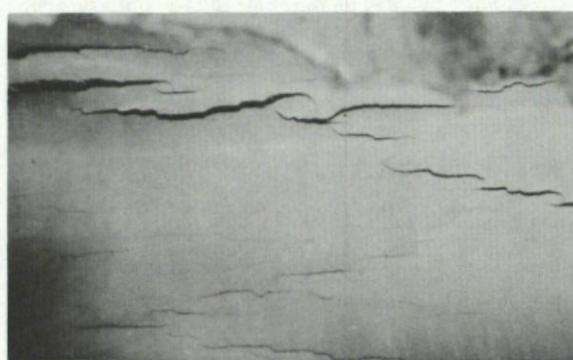
Steel bolts fabricated from 4335V modified low alloy steel were used to secure the main landing gear door hinge on a fighter aircraft. The bolts were heat treated to a hardness of R_c 46-48 and were cadmium plated for corrosion protection. They were made with an interconnecting hole in the top and on the side for hinge lubrication, and these features can be seen in Figure 13-49(a) and Figure 13-49(b), which show a failed bolt. The bolts had been in service for several years, and no previous failures had occurred prior to the failure of the one shown in Figure 13-49.

- (a) Cracked MLG hinge bolt.
- (b) Mating fracture surfaces showing flat fracture.
- (c) Corrosion pits in the lubricating hole.
- (d) Intergranular fracture observed in the initiation region (area 1 in Fig. 13-49(c)).

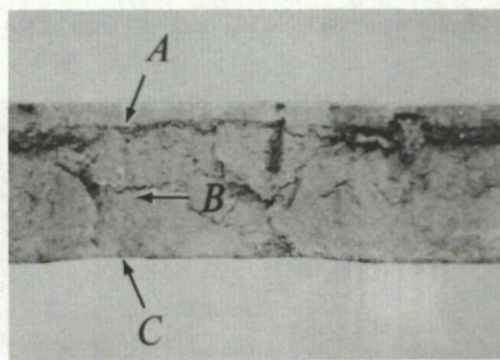
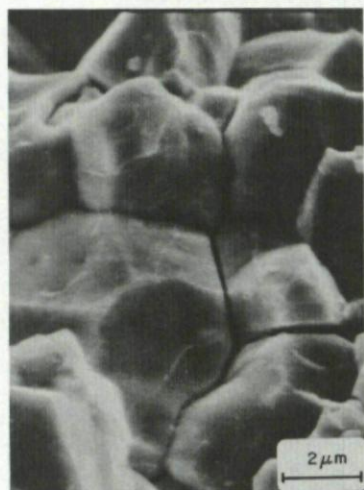
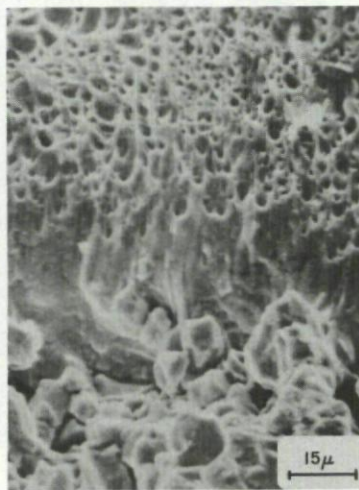
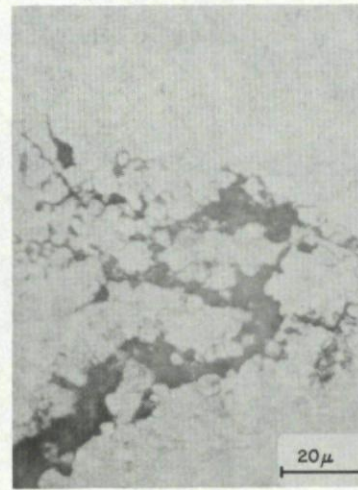
The presence of corrosion products and intergranular fracture in the region of slow crack growth suggested that an environmentally induced fracture mode was operating. The inner surface of the cylinder was found to be covered by a thin film of oil which was analysed and found to be an established hydraulic fluid. Because of the small amount of oil available for analysis it was not possible to determine whether any contaminants were present that might cause corrosion. However, as noted in Section 13-6, it is known that many light oils and hydraulic fluids contain small amounts of water which are sufficient to cause stress corrosion cracking in some susceptible alloys. No other source of corrosion was identified, and in the absence of alternative explanations the failure was attributed to stress corrosion cracking.

Fig. 13-50 Failure of a 18-Ni maraging steel pressure vessel, case history 13-15.

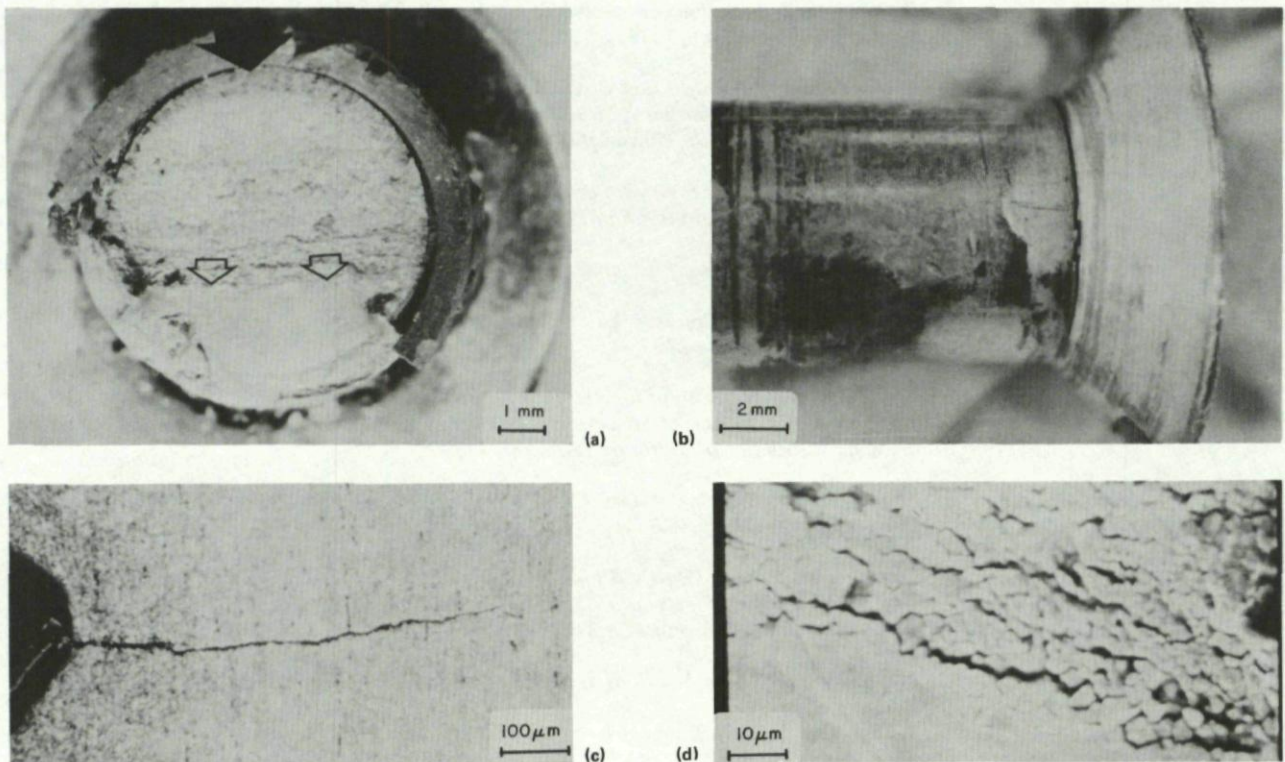
Fig. 13-52 Corrosion induced failure of a 1040 plain carbon steel bolt, case history 13-17.

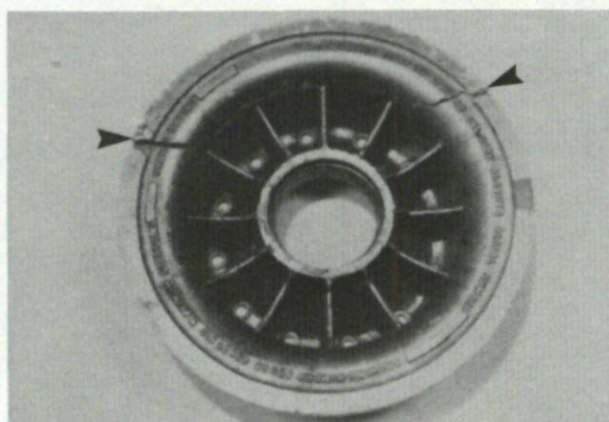
A large rim section was found broken from the rim of a STOL transport aircraft main wheel after landing (Fig. 14-8(a)). The cause of fracture was found to be corrosion fatigue cracking which had grown completely through the rim section. Cracking initiated from the tyre bead seat radius, and the corrosion products were typical of a marine environment.

- (a) General view of the failed wheel and the crack indicated by arrows.
 (b) Section through a typical pit showing multiple corrosion fatigue cracks.
 Nital etch. (Mag. $\times 250$)

Such failures are not likely to occur until the cracking is substantial and then only when side loaded during taxiing, since tyre pressure loads are small. Dye penetrant or eddy current inspection to detect cracking during tyre changes would prevent in-service failures. In this case the frequent experimental tyre changes increased the availability of the corrosive media to the growing undetected cracks.

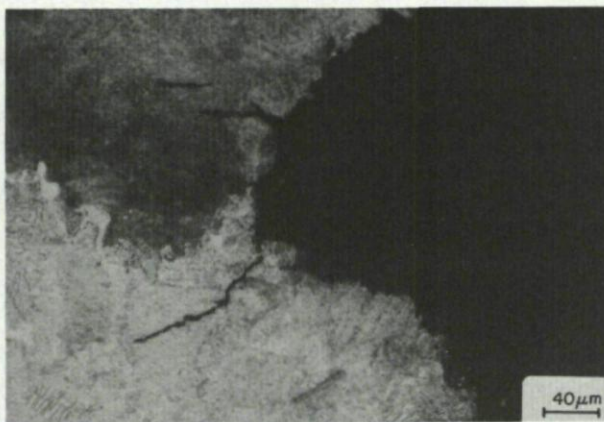
(b)

These experimental low pressure tyre wheels allowed salt moisture to penetrate the tyre bead seat area between tyre and rim, aided by frequent tyre changes. The wheel was a magnesium alloy casting (AZ-91C) and fatigue crack initiation occurred at the base of deep corrosion pits. Figure 14-8(b) shows a typical pit with multiple crack origins.

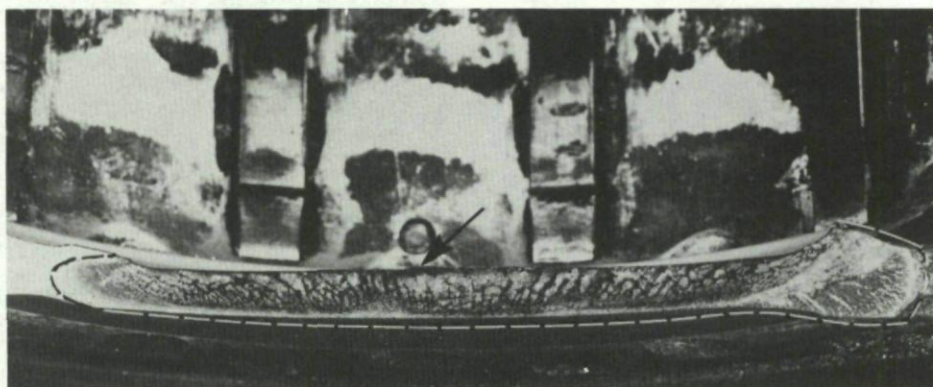
Long cracks were found during visual inspection of a fighter aircraft main landing gear wheel. The cracks were approximately 125 mm long and were found to run between the rim of the wheel and a bolt hole, as shown in Figure 14-9(a). The crack initiation site is indicated by the arrow in Figure 14-9(b).

(a) General view of the wheel showing the crack.

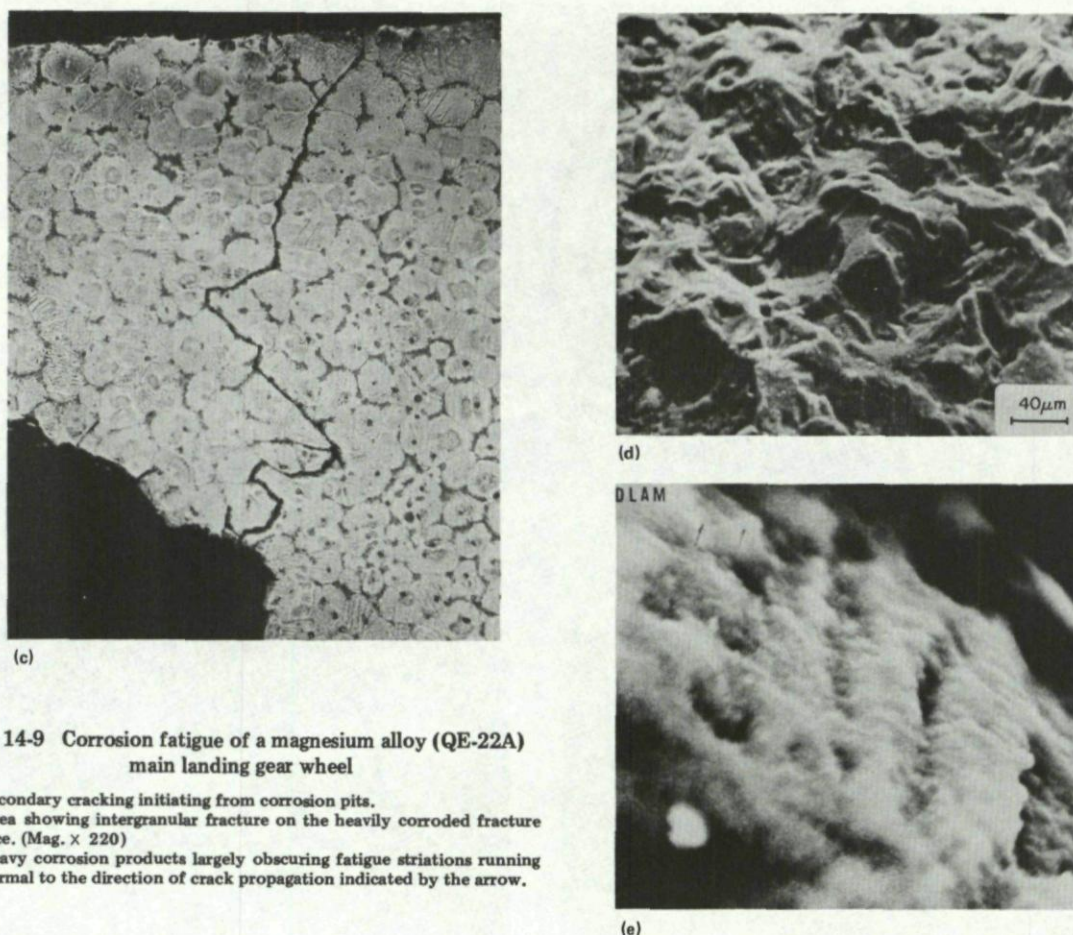
Fig. 14-9 Corrosion fatigue of a magnesium alloy (QE-22A) main landing gear wheel

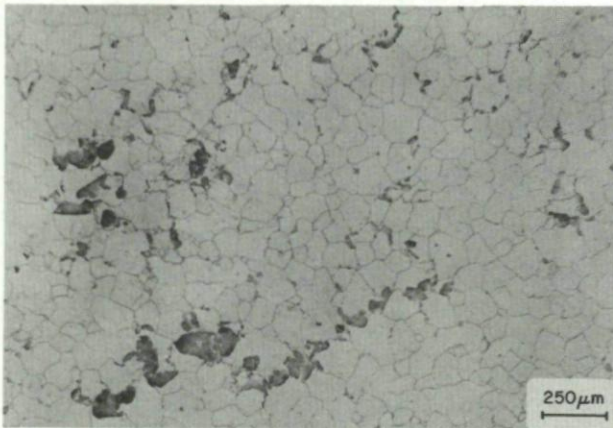
Multiple cracks were found propagating out of bolt housings during a visual and liquid penetrant inspection of the nose wheels of a fleet of fighter aircraft. Many wheels were found to be affected, and typical cracks are indicated by the arrows shown in Figure 14-10(a).

- (a) General view of two wheels showing cracks (arrows) growing out of bolt holes.
- (b) Microstructure of the AZ-91C magnesium alloy. (Mag. $\times 45$)
- (c) Fracture surface showing the corroded (dark) pre-cracked area 'A', and the bright final fracture zone 'B'.
- (d) Inner surface of a bolt hole showing a deep corrosion pit. (Mag. $\times 1200$)
- (e) Intergranular cracking in the initiation zone. (Mag. $\times 260$)
- (f) Fatigue striations in a transgranular portion of the fracture surface. (Mag. $\times 650$)

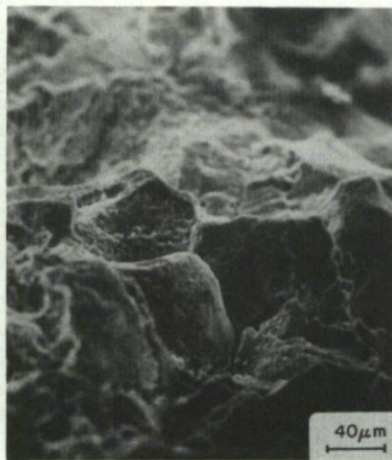
(e)

Several cracks were opened in the laboratory, and these showed a dark zone, covered by corrosion products, which extended up to the bright overload zone produced during opening (Fig. 14-10(c)). The inner surfaces of the bolt holes were also examined. These were found to contain deep corrosion pits of the type shown in Figure 14-10(d). Examination of the fracture surfaces using a scanning electron microscope showed that intergranular cracking had occurred in the initiation regions (Fig. 14-10(e)), while transgranular fracture had occurred at longer crack lengths (Fig. 14-10(f)). Both the intergranular and transgranular zones were badly corroded, but fatigue striations were clearly visible in the transgranular areas (Fig. 14-10(f)).

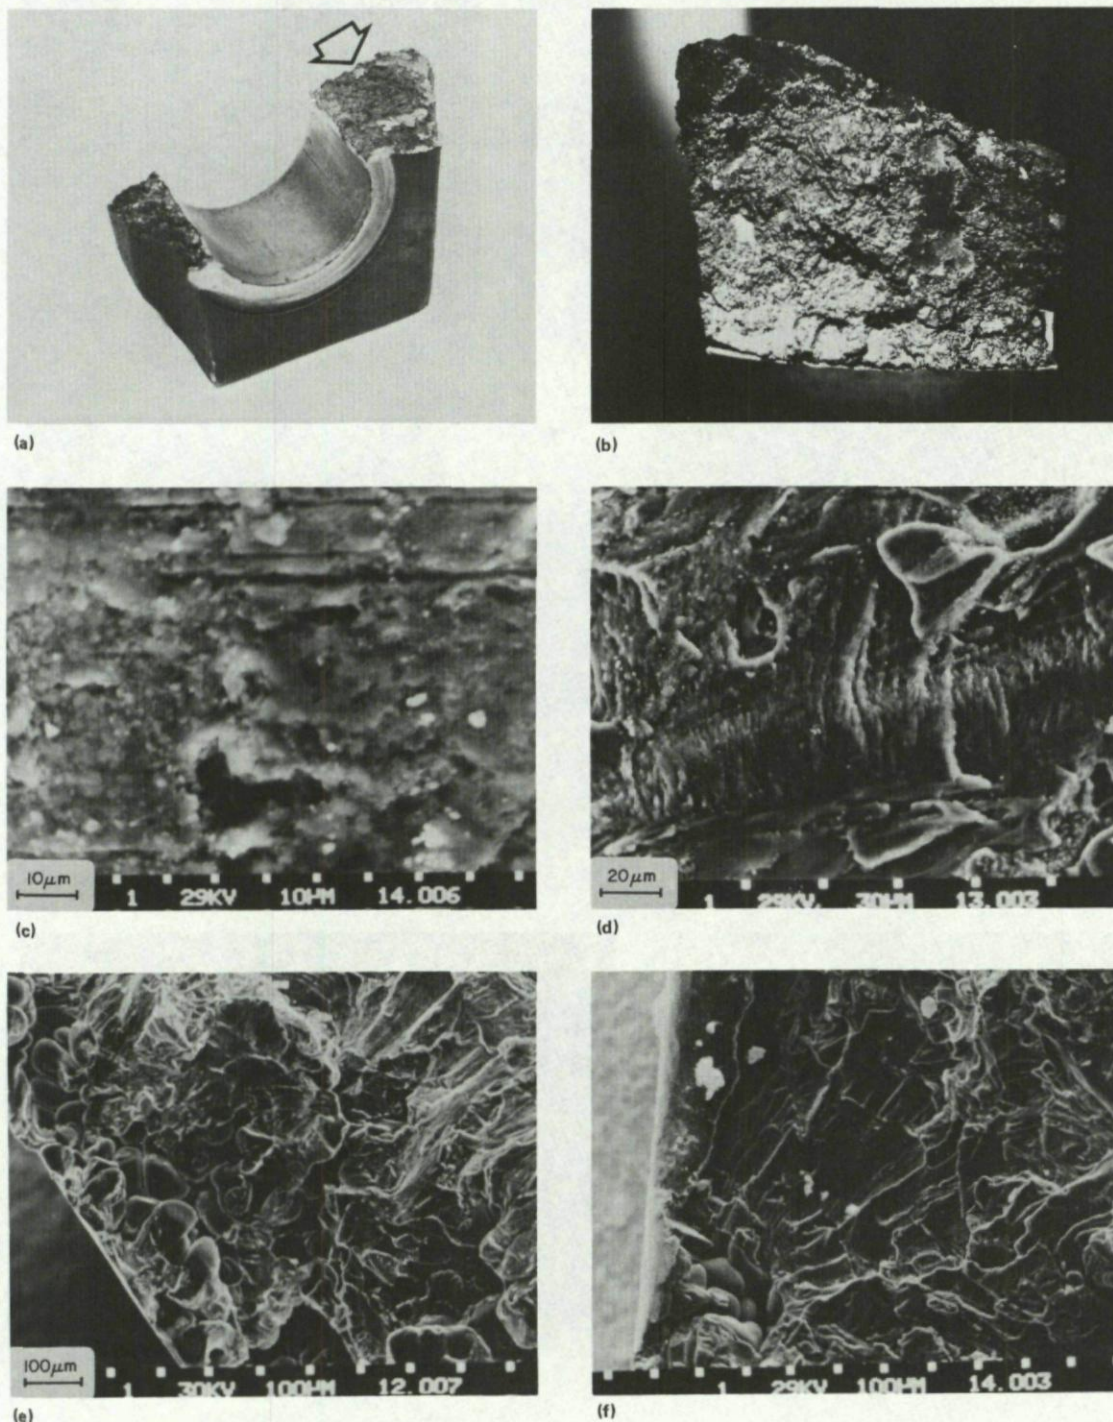
Fig. 14-11 Corrosion fatigue of a cast aluminium rocker arm journal bearing

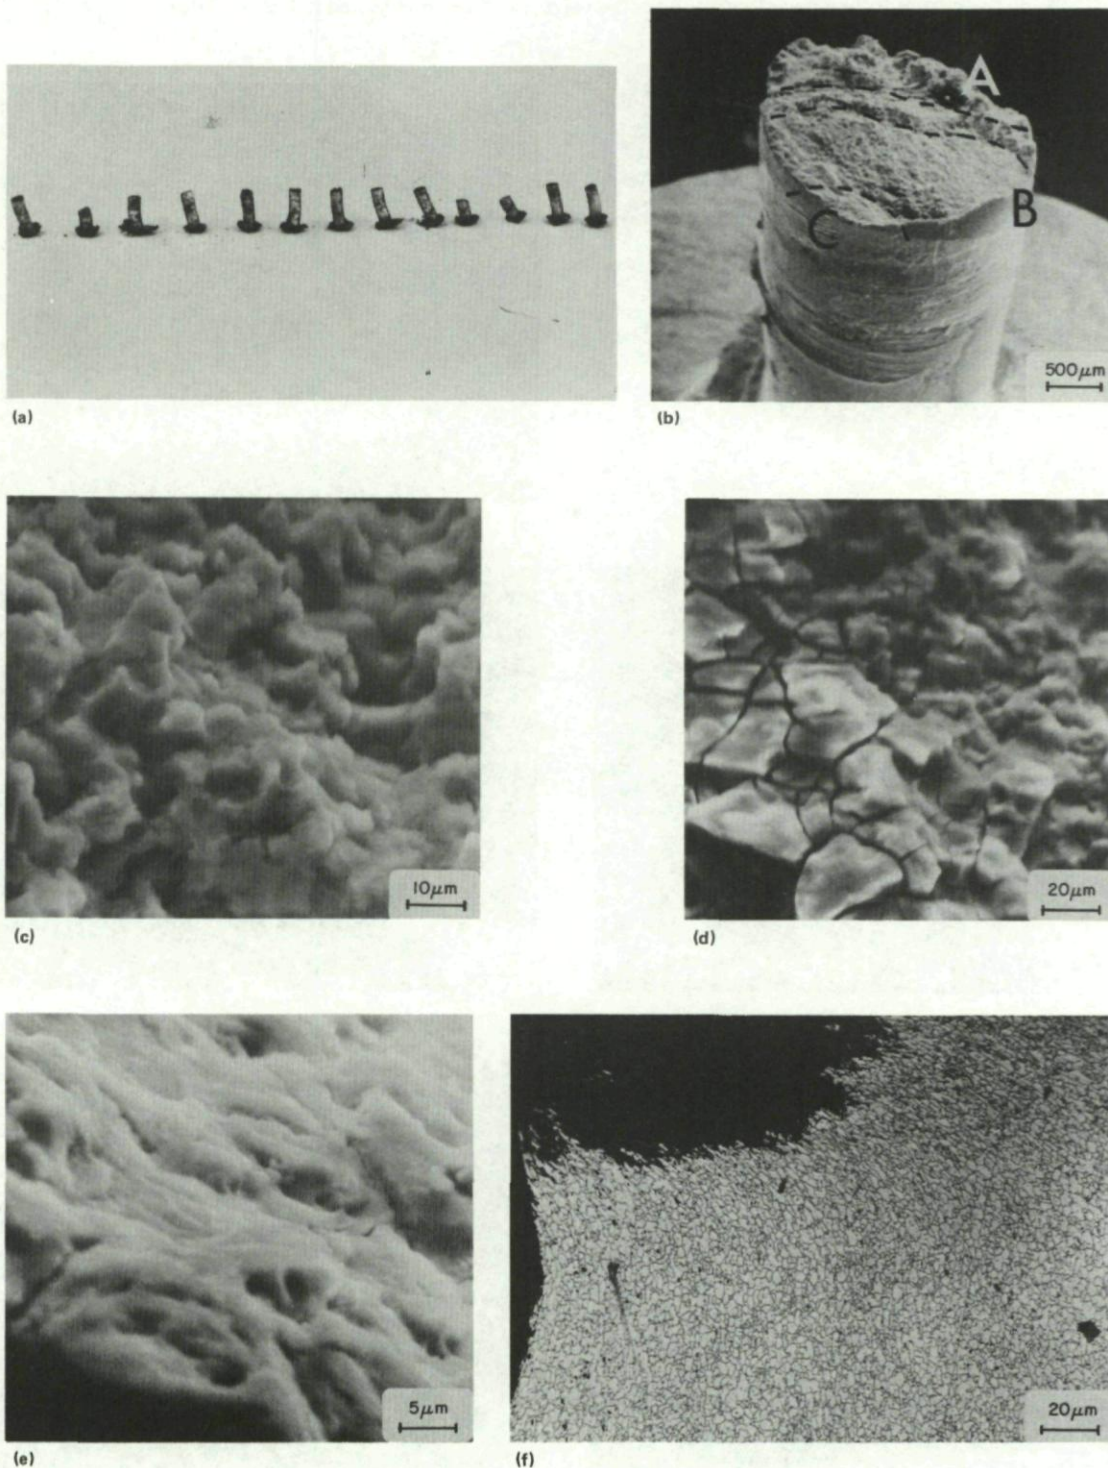
Fig. 14-12 Corrosion fatigue of 5052 aluminium alloy rivets

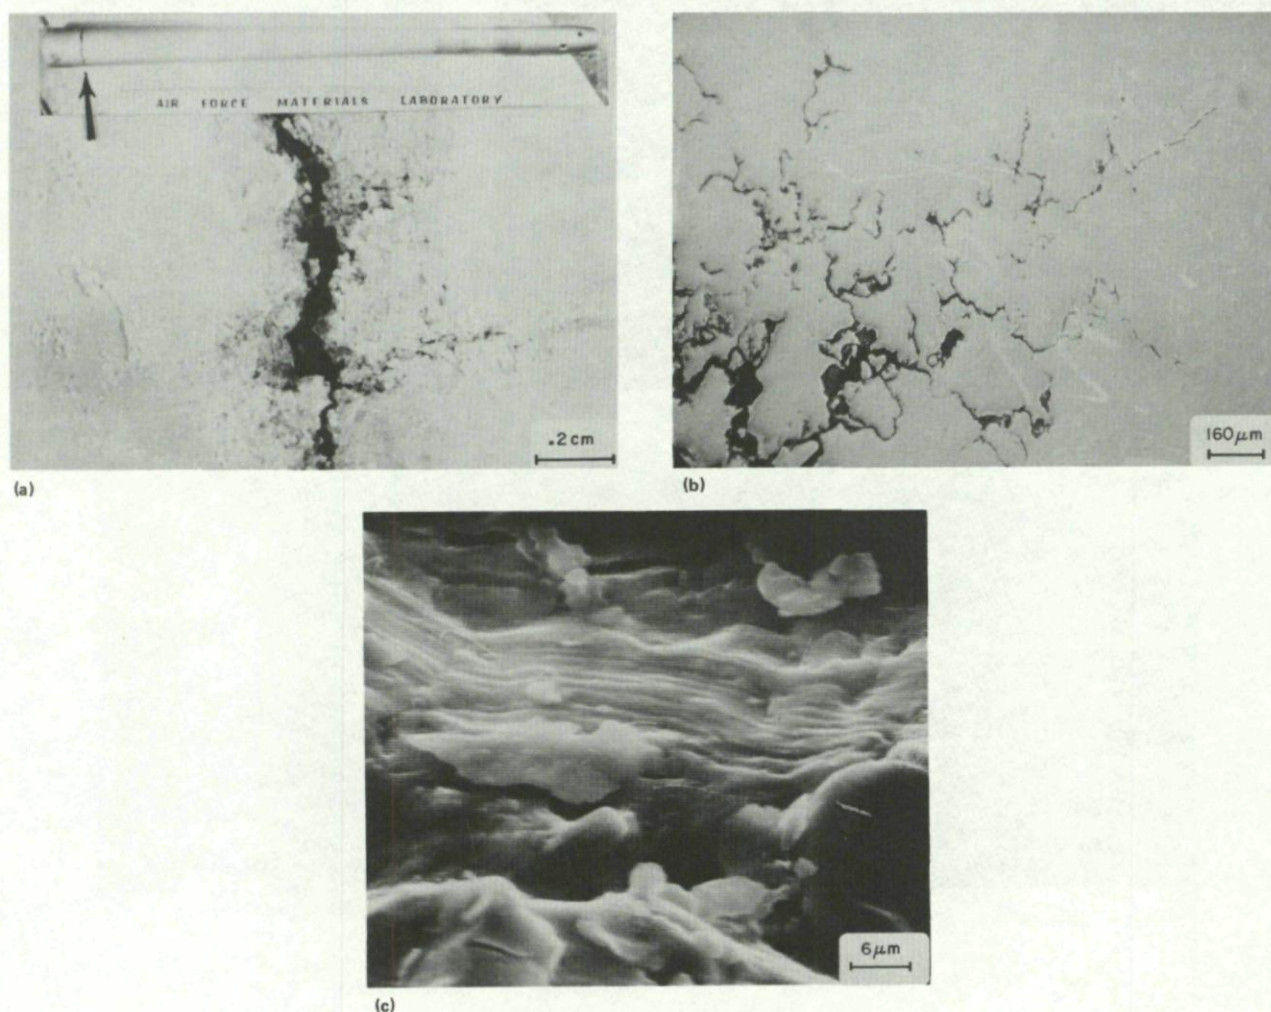
Fig. 14-13 Corrosion fatigue in a 6061 aluminium pitot support tube
